An analysis of lakes and streams in the Barbee and Chapman lake chains in Kosciusko County, Indiana

Nathan Bosch, Anna Burke, Logan Gilbert, Alixandra Underwood

Center for Lakes & Streams, Grace College, Winona Lake, IN 46590, USA

Date submitted: August 13, 2014

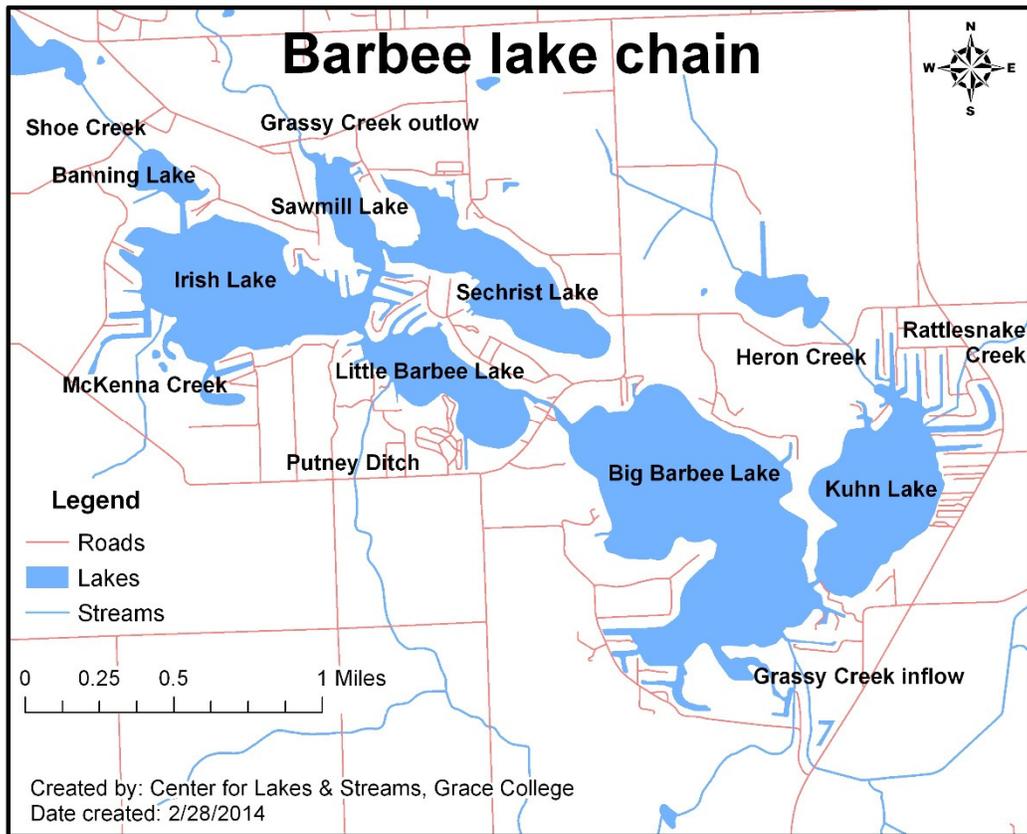
Figure 1: Map showing Barbee lake chain, including locations of seven lakes and seven streams included in present study.

The Barbee and Chapman lake chains are located in the glacial lakes area of northern Indiana in Kosciusko County. The lakes are part of the Tippecanoe watershed (HUC 05120106) which drains into the Wabash River near Lafayette, Indiana. For the purposes of the present study, the Barbee lake chain (HUC 051201060105) included Banning, Irish, Little Barbee, Big Barbee, Kuhn, Sechrist, and Sawmill lakes as well as the following streams: Putney Ditch (inflow to Little Barbee), Heron Creek (inflow to Kuhn), Rattlesnake Creek (inflow to Kuhn), Shoe Creek (inflow to Banning), Grassy Creek outflow (outflow from Sawmill), Grassy Creek inflow (inflow to Big Barbee), and McKenna Creek (inflow to Irish) (Figure 1).

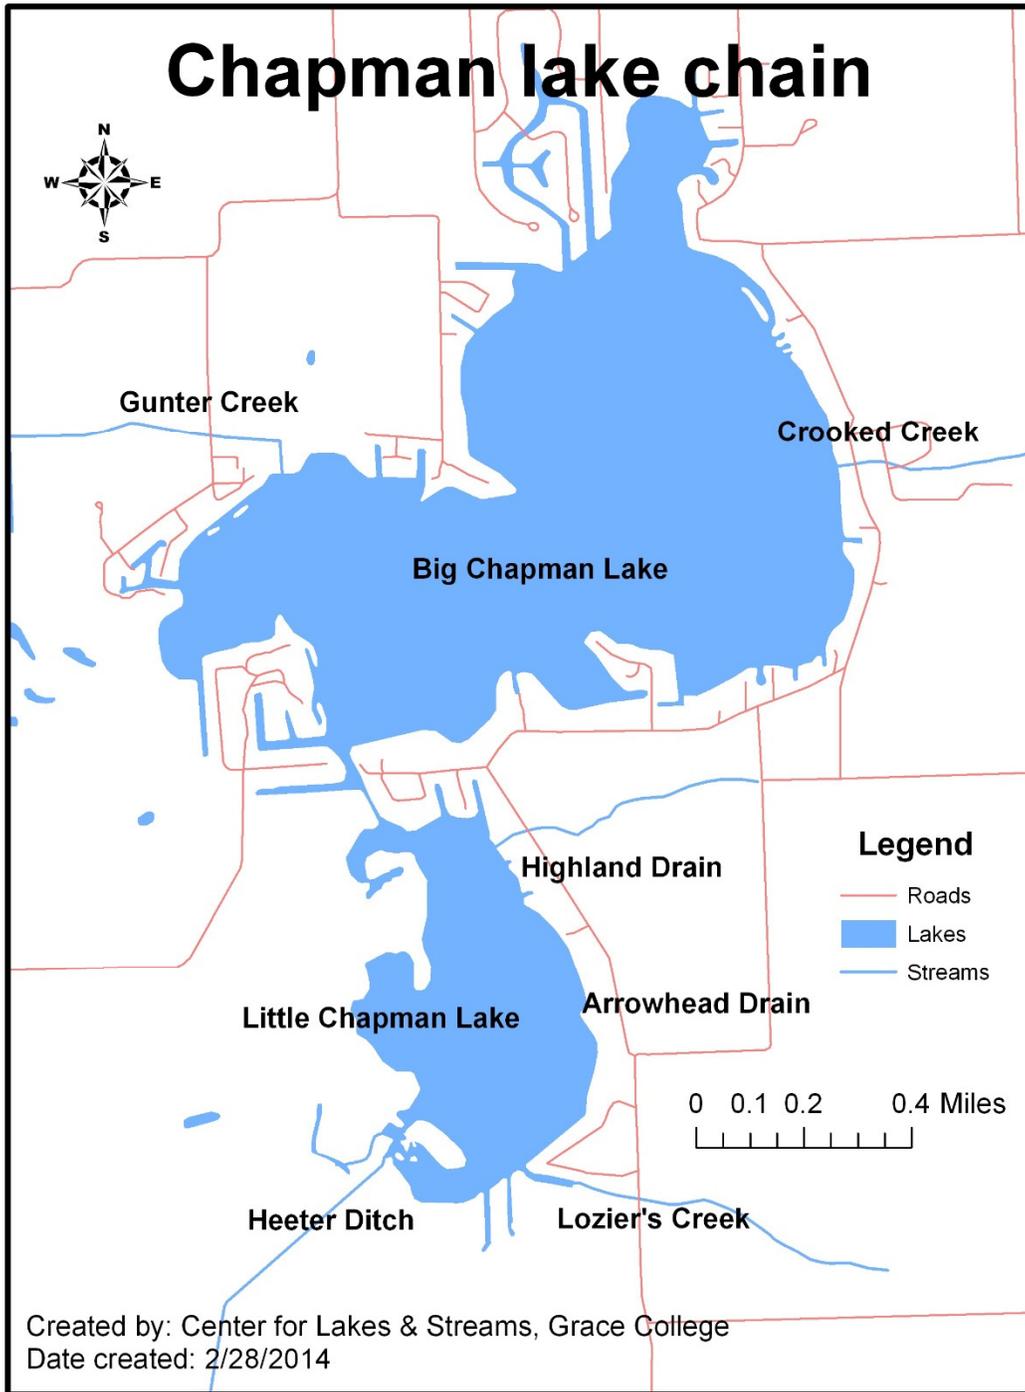
Figure 2: Map showing Chapman lake chain, including locations of two lakes and six streams included in present study.

The Chapman lake chain (HUC 051201060205) included Big Chapman Lake and Little Chapman Lake along with the following streams: Heeter Ditch (outflow from Little Chapman), Arrowhead Drain (inflow to Little Chapman), Highland Drain (inflow to Little Chapman), Crooked Creek (inflow to Big Chapman), Gunter Creek (inflow to Big Chapman, may also be known as C27 Creek or Island Park Drain), and Lozier’s Creek (inflow to Little Chapman)(Figure 2). Sampling sites for lakes were located in the deepest hole in each lake. Sampling sites for streams were typically chosen near a road crossing as close to lake as possible (Table 1).

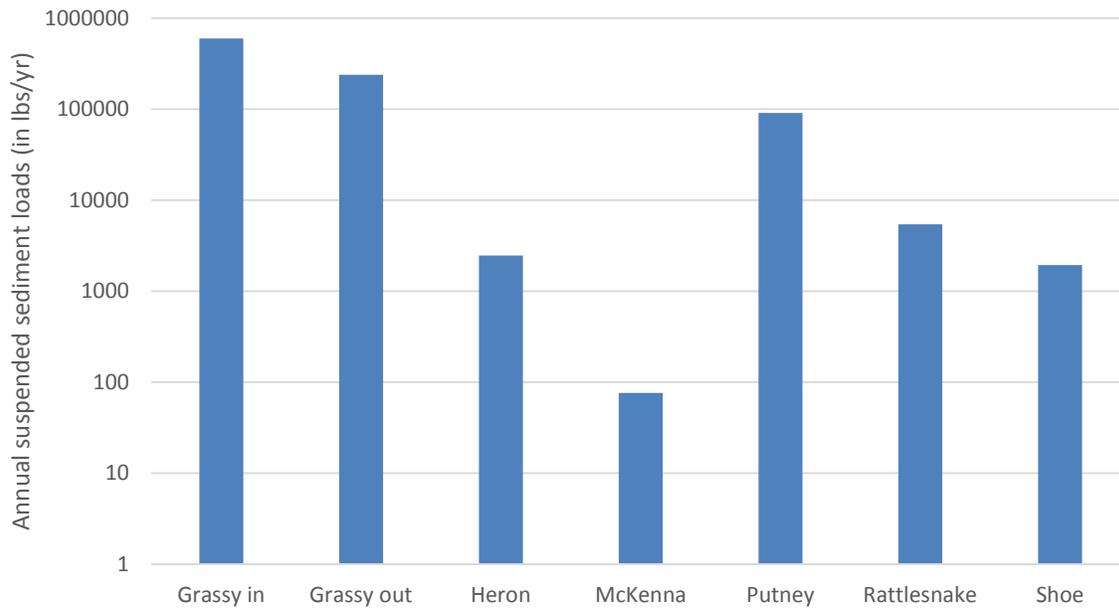
Figure 3: Annual suspended sediment loads (in lbs/yr) for Barbee stream sites. Note that scale on vertical axis is logarithmic to show smaller and larger loads on same figure.

As stated above, annual stream loading estimates for sediments and nutrients were uncertain due to drought conditions over the study period, but some interesting observations could be made despite this. The Barbee streams showed high loads of sediments, phosphorus, and nitrogen in the dominant loading streams (Grassy Creek and Putney Ditch) relative to the largest loading stream (Crooked Creek) in the Chapman chain (Figures 3-8). Future efforts to control sediment and nutrient loading to these two lake chains should consider these major loading streams as top priorities.

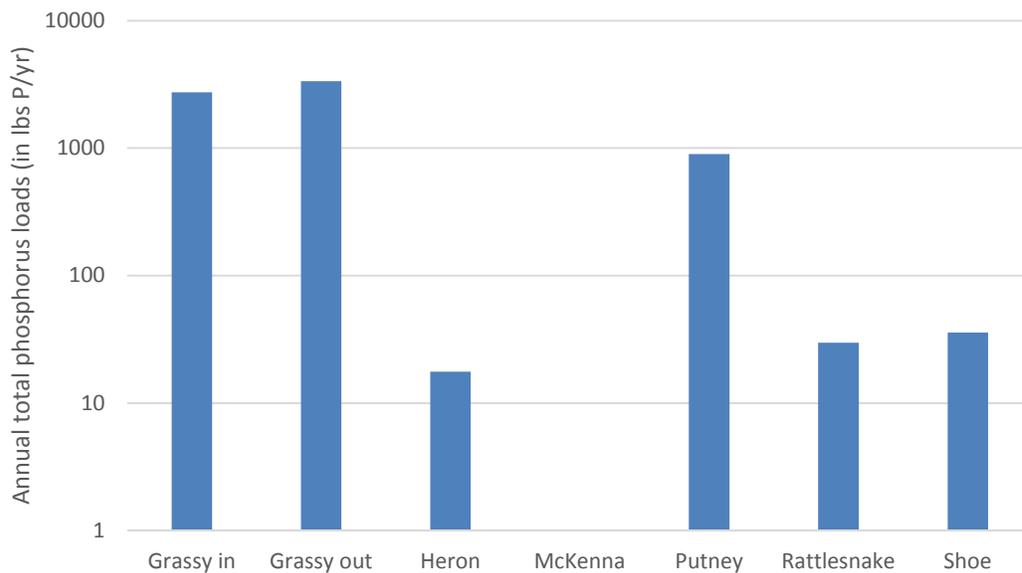
Figure 4: Annual total phosphorus loads (in lbs P/yr) for Barbee stream sites. Note that scale on vertical axis is logarithmic to show smaller and larger loads on same figure.

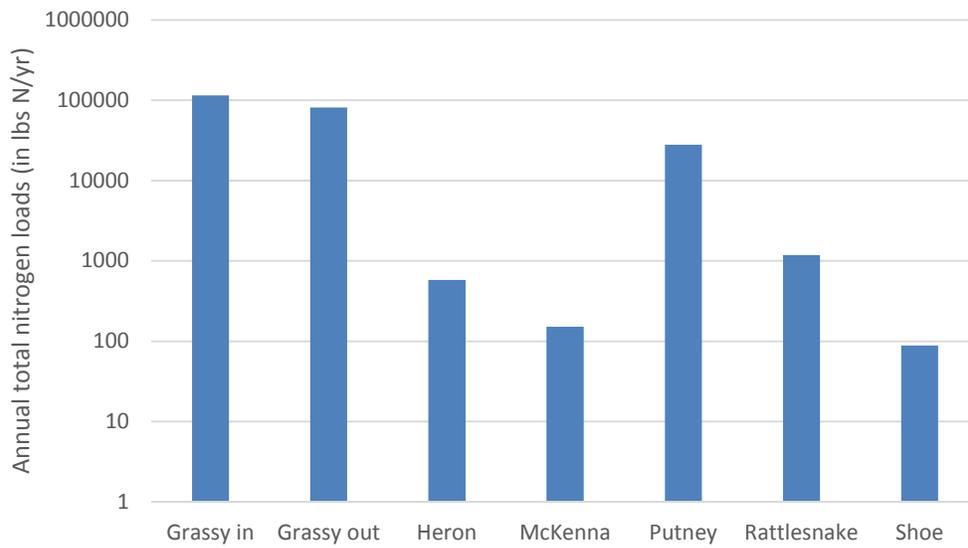
Figure 5: Annual total nitrogen loads (in lbs N/yr) for Barbee stream sites. Note that scale on vertical axis is logarithmic to show smaller and larger loads on same figure.

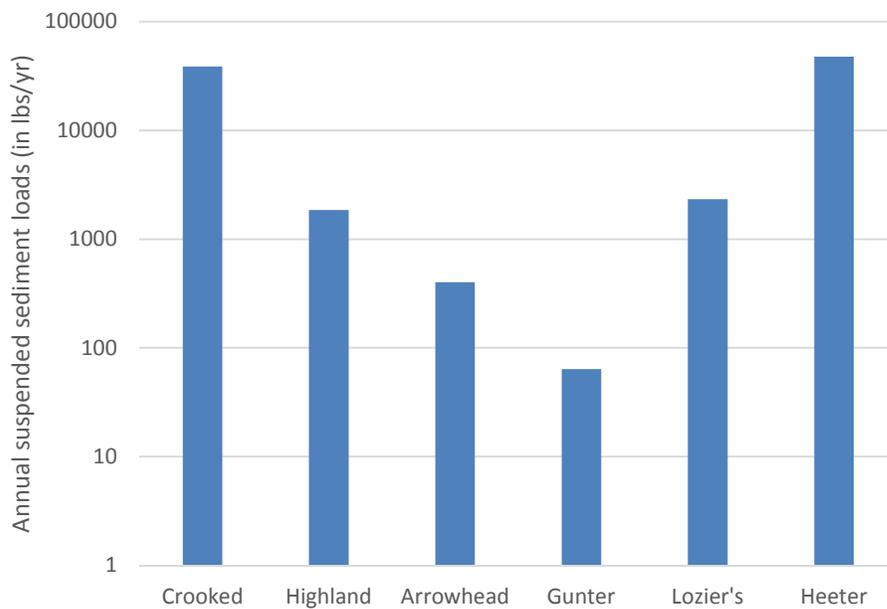
Figure 6: Annual suspended sediment loads (in lbs/yr) for Chapman stream sites. Note that scale on vertical axis is logarithmic to show smaller and larger loads on same figure.

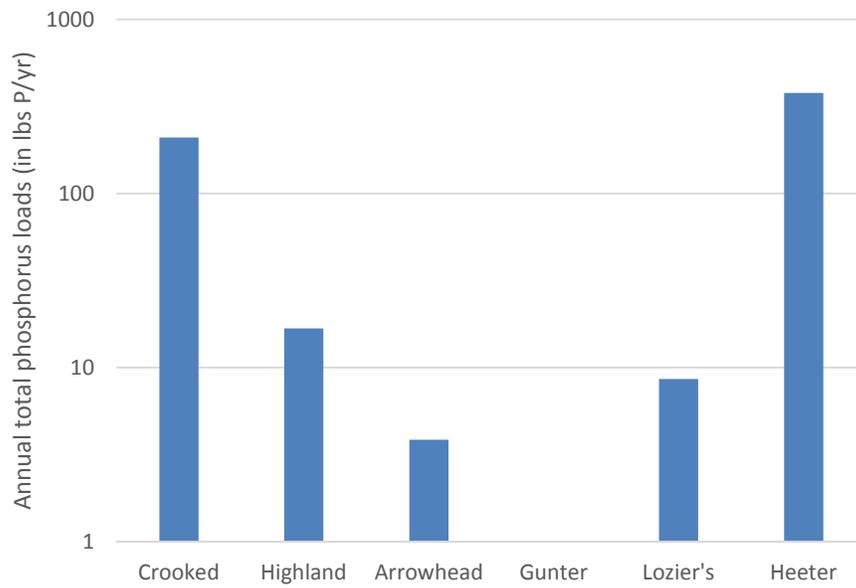
Figure 7: Annual total phosphorus loads (in lbs P/yr) for Chapman stream sites. Note that scale on vertical axis is logarithmic to show smaller and larger loads on same figure.

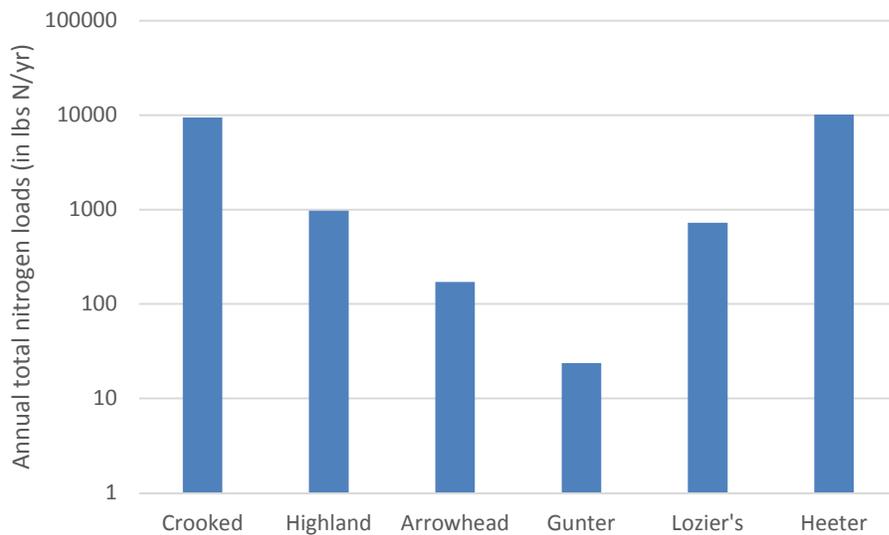
Figure 8: Annual total nitrogen loads (in lbs N/yr) for Chapman stream sites. Note that scale on vertical axis is logarithmic to show smaller and larger loads on same figure.
